## EVALUATION REPORT OF LIQUID PIPELINE CONSTRUCTION

| Inspection Report | | Post Inspection Memorandum | |
|---|---|---|---|
| Name of Operator: | TransCanada Oil Pipeline Operations Inc. | OPID #: | 32334 |
| Name of Unit(s): | Keystone Gulf Coast Pipeline North / Keystone Gulf Coast Pipeline South | Unit #(s): | 74979,83245 |
| Inspection Type: | Construction | Inspection Date(s): | 2011-2014 |

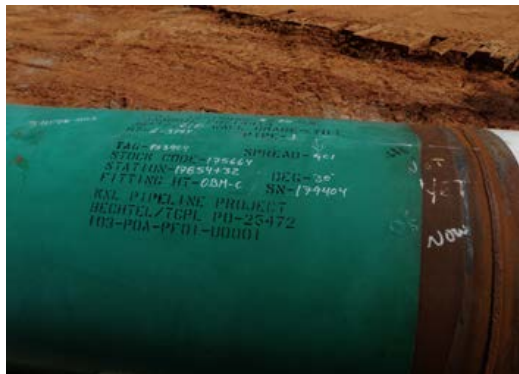
### Figure 1: Pipe Specification Markings

During the field inspections, the pipeline was verified for design specifications by examining the pipe for manufacturer stamping and reviewing manufacturer test reports (MTRs). Each pipe joint was marked with length, grade, pipe size, and specification. See Figures 1 and 2 for examples.

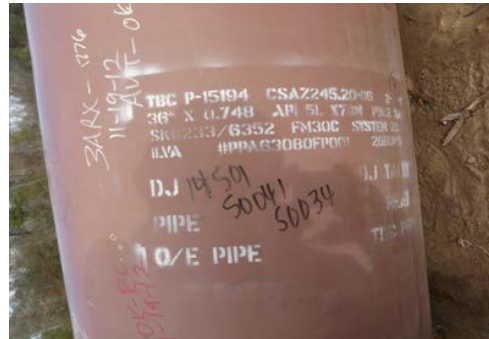
Pipe used for the construction had different wall thicknesses for different application locations such as: 0.465" for line pipe, 0.515" for HCAs, 0.572" downstream of pump station, 0.618" for road bores, and 0.748" for HDDs. HDD and road bore pipe also had abrasion resistant overcoat (ARO) which was verified during the field inspections as seen in Figure 3. Pipe joints were marked with the appropriate specifications, for example, API 5L PSL2 36", 0.465", X70.

**Figure 3: ARO Pipe with specification markings.**

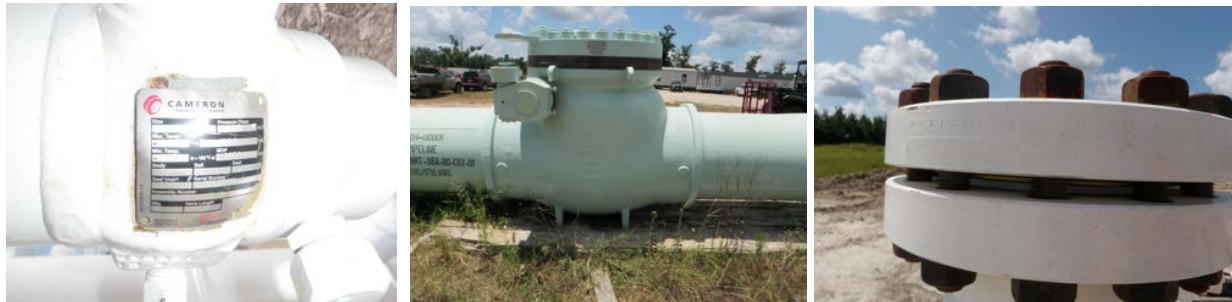
**Figures 4, 5, 6: Manufacturer Stamp on Valve, and Flange**

examined for damage such as buckles, dents, gouges, cracks or other defects that might reduce the strength. Pipe joints were tracked by a labeling system with a bar code. See Figures 4-6.

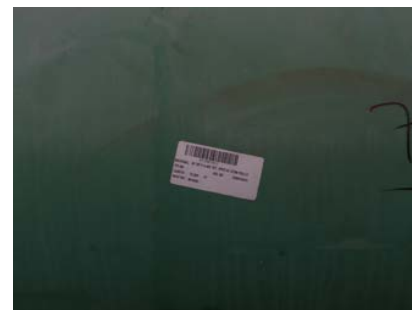
**Figure 7: Pipe Label**

Labels were checked in the field for damage or non-readable labels. See Figure 7. All components inspected were consistent with the pressure rating and in accordance with the established MOP.

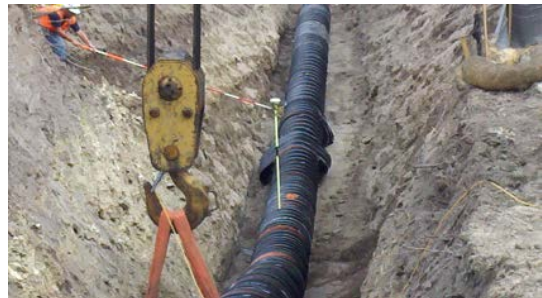
**Figure 9: Depth of Cover check with GPS**

During the field inspections, PHMSA inspected the pipeline ROW for any private dwellings, industrial buildings, and places of assembly. The ROW of the pipeline avoided and was not in close proximity to any of these structures or locations. The inspection of soil cover and depth of pipe was in compliance with the regulations. The pipeline had a cover of at least the minimum cover required at all locations inspected during the field inspections. Figure 8 shows the depth of the pipe. The Figure demonstrates the cover and depth of the pipeline and the remoteness of the pipeline ROW. Figure 9 shows the depth of pipeline is verified with a GPS system.

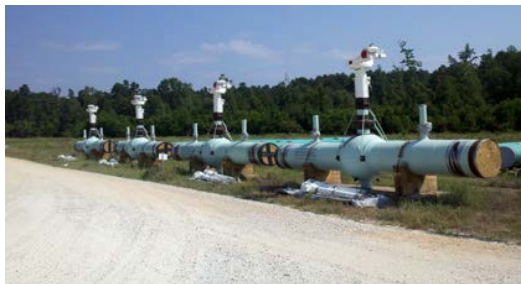
**Figure 15: Valve Storage at Pipe Yard**

Valves were inspected at the pipe yard on several occasions to verify the rating and condition of the valves. Figure 15 shows valves inspected at the pipe yard. Valves were stored away from the pipe to protect from any damage.

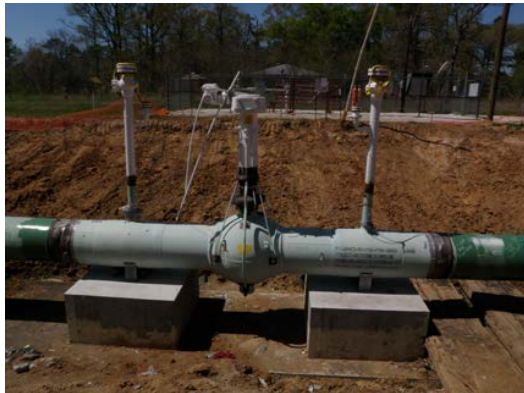
**Figure 17: Concrete Pads for Valves.**

All valves are motorized and remotely operational through SCADA. All valves had concrete foundation poured to handle any stresses the weight may put on the pipeline. Figure 17 is an example of concrete supports. Figure 18 demonstrates the protection from unauthorized personnel and vandalism. In addition, the photos show the satellite, electric power and generators for backup needed to operate the valves.

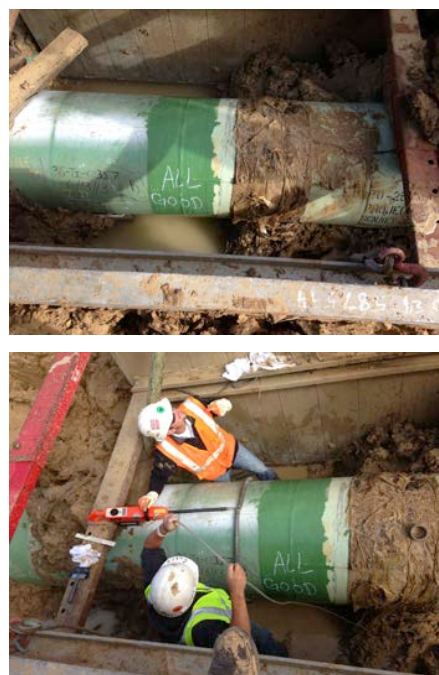
TransCanada conducted a Direct Current Voltage Gradient (DCVG) survey of the entire Keystone Gulf Coast Pipeline to check for any coating damage. After the survey, TransCanada submitted the findings of any coating damage found along with repairs made on anomalies. There were a total of 127 anomalies on Spread 1, 83 anomalies on Spread 2, and 43 anomalies on Spread 3 found by the survey. None of the anomalies found met the repair criteria of 35% IR, the highest was 32%. TransCanada performed verification digs on the highest IR readings on all three spreads to assure accuracy of the DCVG Survey. They made 8 digs in Spread 1, 8 digs in Spread 2, and 4 digs in Spread 3 and made repairs accordingly. The reports were reviewed by PHMSA to assure compliance with their procedures and the regulations. PHMSA conducted field inspections to verify dig sites identified by the DCVG survey. Figures 25 and 26 depict two locations identified by the DCVG survey during a PHMSA field inspection.

**Figure 25 and 26: DCVG dig site (recoated)**
