## EVALUATION REPORT OF LIQUID PIPELINE CONSTRUCTION

| Inspection Report | | Post Inspection Memorandum | |
|---|---|---|---|
| Name of Operator: | TransCanada Oil Pipeline Operations Inc. | | OPID #: 32334 |
| Name of Unit(s): | Keystone Gulf Coast Pipeline North / Keystone Gulf Coast Pipeline South | | Unit #(s): 74979,83245 |
| Inspection Type: | Construction | | Inspection Date(s): 2011-2014 |

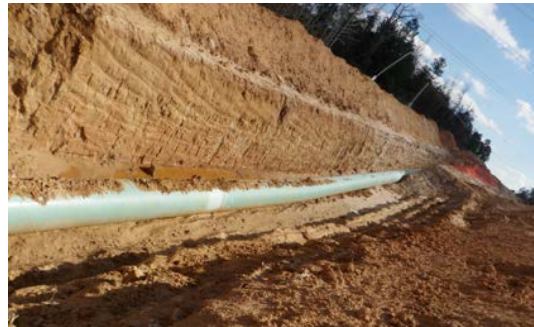
**Figure 8: Typical Right of Way depicting Depth of Cover.**

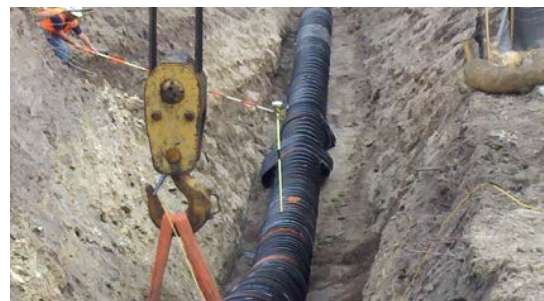
**Figure 9: Depth of Cover check with GPS**

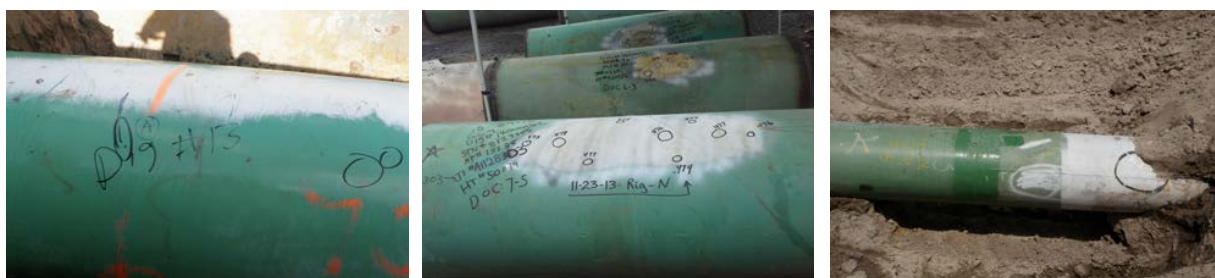
TransCanada did not assure that its Keystone Pipeline was installed in the ditch in a manner that minimizes the possibility of damage to the pipe. The deformation tool identified dents on the pipe that appear to be caused by secondary stresses on the pipe. The ILI tool identified a total of 421 anomalies which required investigation per the specifications. There were a total of 236 dents, 56 pipe ovality and 129 anomalies with both dent and ovality. TransCanada verified the locations by excavating the anomalies and made repairs in accordance with their specifications. After excavating and examining the anomalies, there were a total of 350 anomalies within the specifications, 37 anomalies which required being cut-out and 34 anomalies with no indications of a dent or ovality. During the field inspections, PHMSA witnessed and examined anomaly investigations being conducted by TransCanada due to the results of the deformation tool run. In this report you can see examples of the types of dents identified with the inspection tool. Each dent was examined

**Figure 32, 33, 34 Examples of dents found with inspection tool.**

and measured and nondestructively tested with ultrasound testing equipment to check for cracks. All dents were either cutout or were below the repair criteria. Several anomaly reports stated that foam pillows and rocky terrain were present at the dig sites which may
