## Post-Construction Haul Route Evaluation Report

North Bend Wind Project  
Hyde County, South Dakota  
UEI Project No. 23.22932

*Prepared for  
Hyde County, South Dakota*

*Prepared by  
Ulteig Engineers, Inc.  
July 2024*

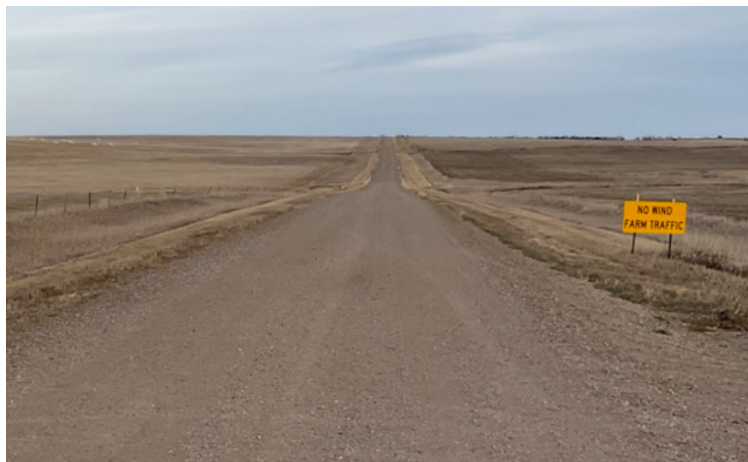
*Photo Caption: This sign was placed along 209<sup>th</sup> St. It is believed that wind farm equipment was not used along most of the 209<sup>th</sup> St route.*

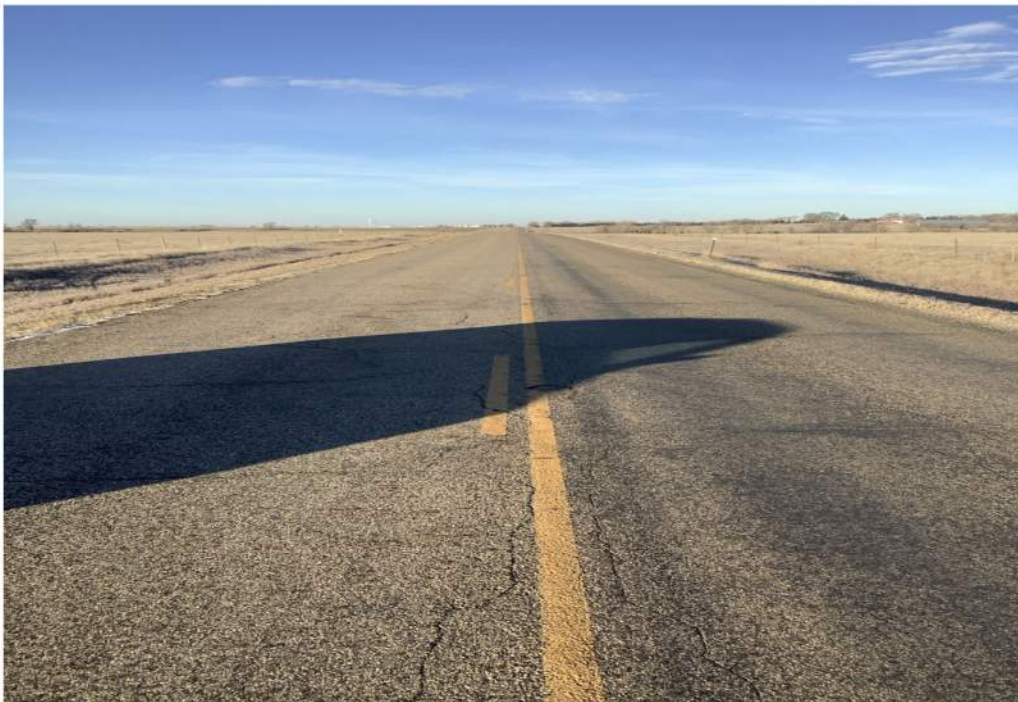
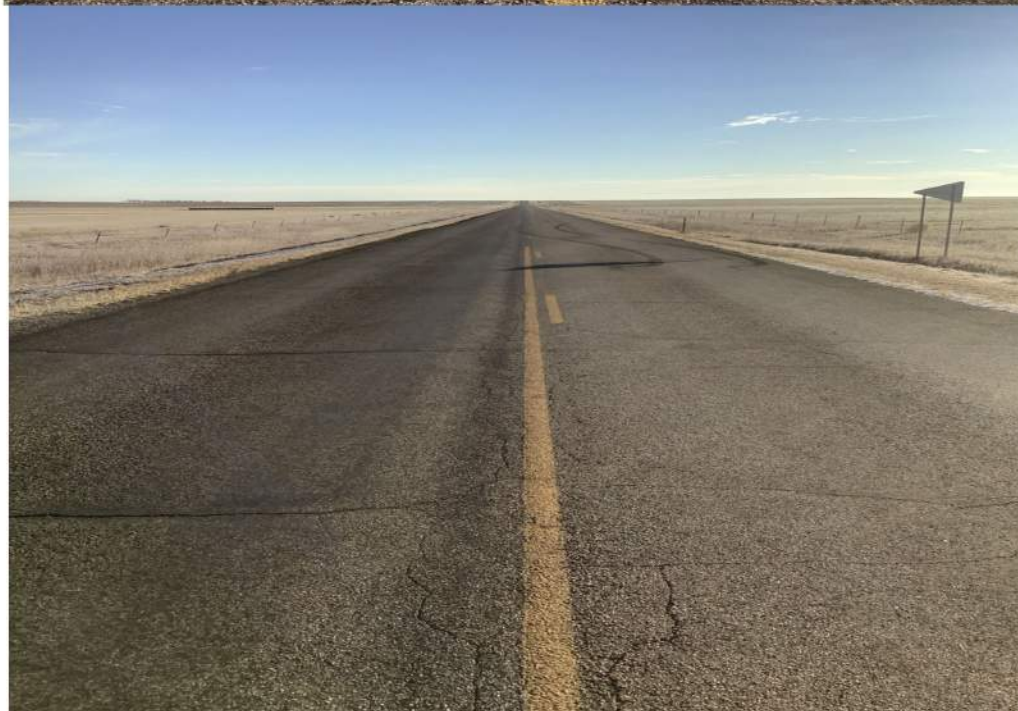
Asphalt PASER Condition: 216th St -- 338th Ave to 339th Ave

| Route | Post-Con ID | Owner | Location | | Length (mi) | Roadway Width (ft) | Pre-Con PASER Rating (1-10) | | Post-Con PASER Rating (1-10) | | Recommended Restoration | Post-Construction Notes |
|---|---|---|---|---|---|---|---|---|---|---|---|---|
| 216th St | 1 | Hyde County | 338th Ave | 339th ave | 1.0 | 28 | | 5 | | 4 | Action needed.* | Conditions appear to have worsened overall.<br>Two new asphalt spot distresses noted. |

| Comment | Conditions appear to have worsened overall. Two new asphalt spot distresses noted. | | |

\*It is understood that discussions are being held to address the worsened asphalt conditions.

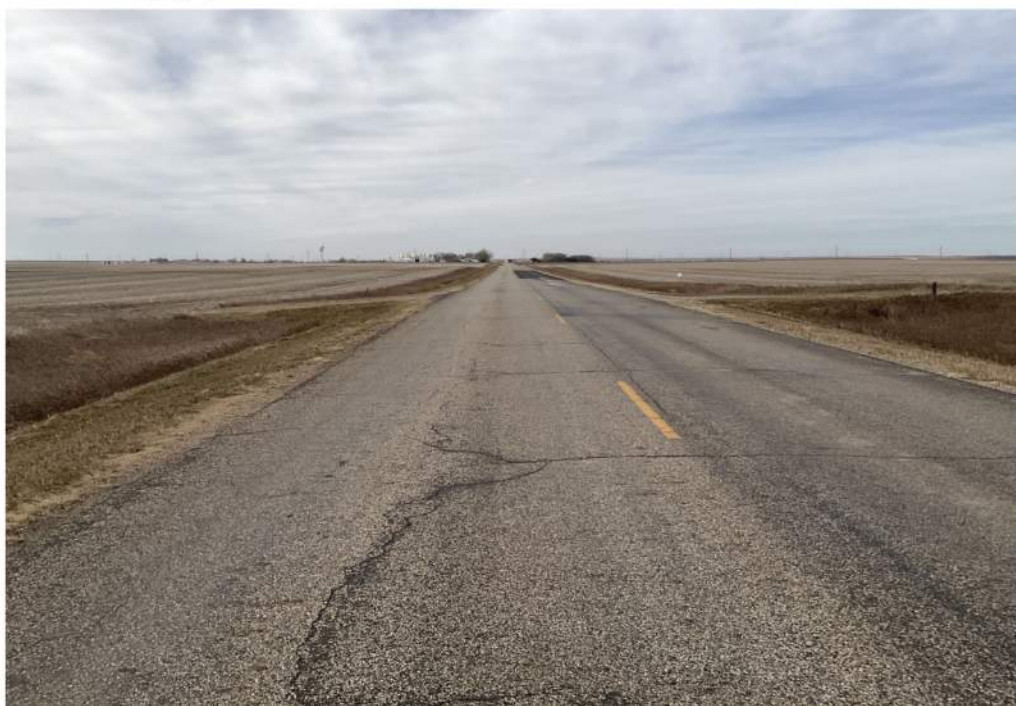
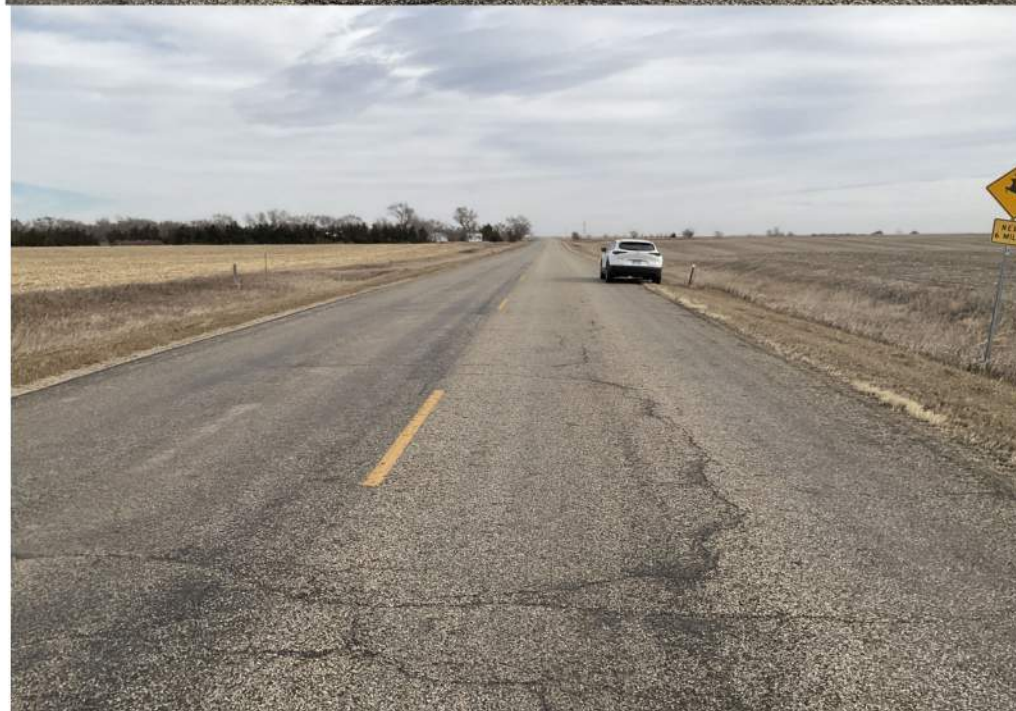
Asphalt PASER Condition: 216th St -- SD HWY 47 to 338th Ave

| Route | Post-Con ID | Owner | Location | | Length (mi) | Roadway Width (ft) | Pre-Con PASER Rating (1-10) | | Post-Con PASER Rating (1-10) | | Recommended Restoration | Post-Construction Notes |
|---|---|---|---|---|---|---|---|---|---|---|---|---|
| 216th St | 2 | Hyde County | SD Hwy 47 | 338th Ave | 1.0 | 28 | | 5 | | 4 | Action needed.* | Conditions appear to have worsened overall. |

| Comment | Conditions appear to have worsened overall. | | |

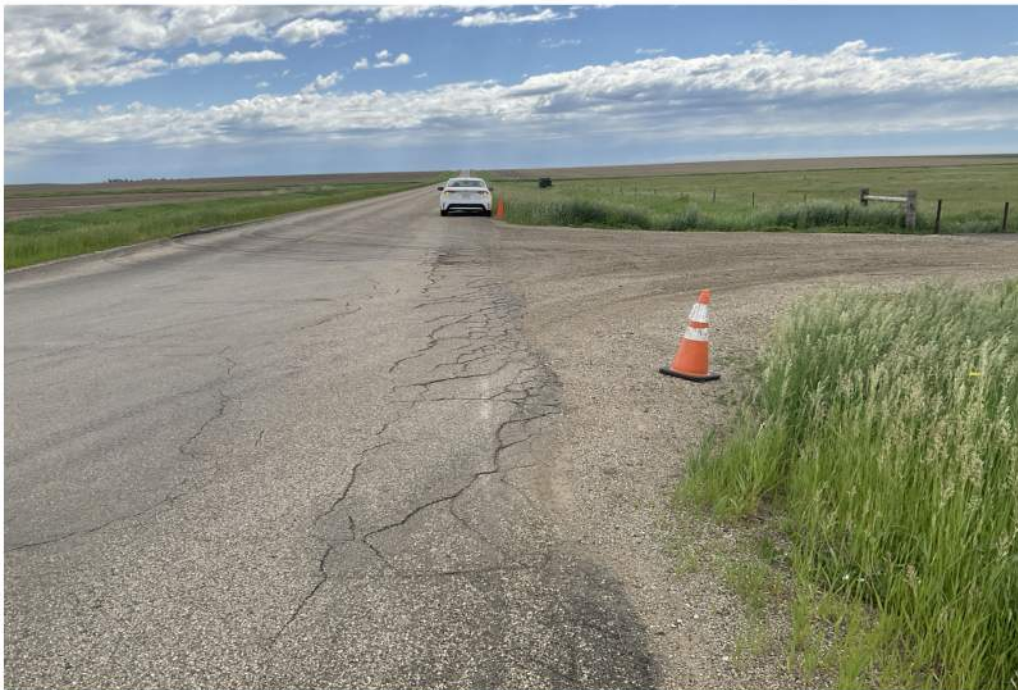
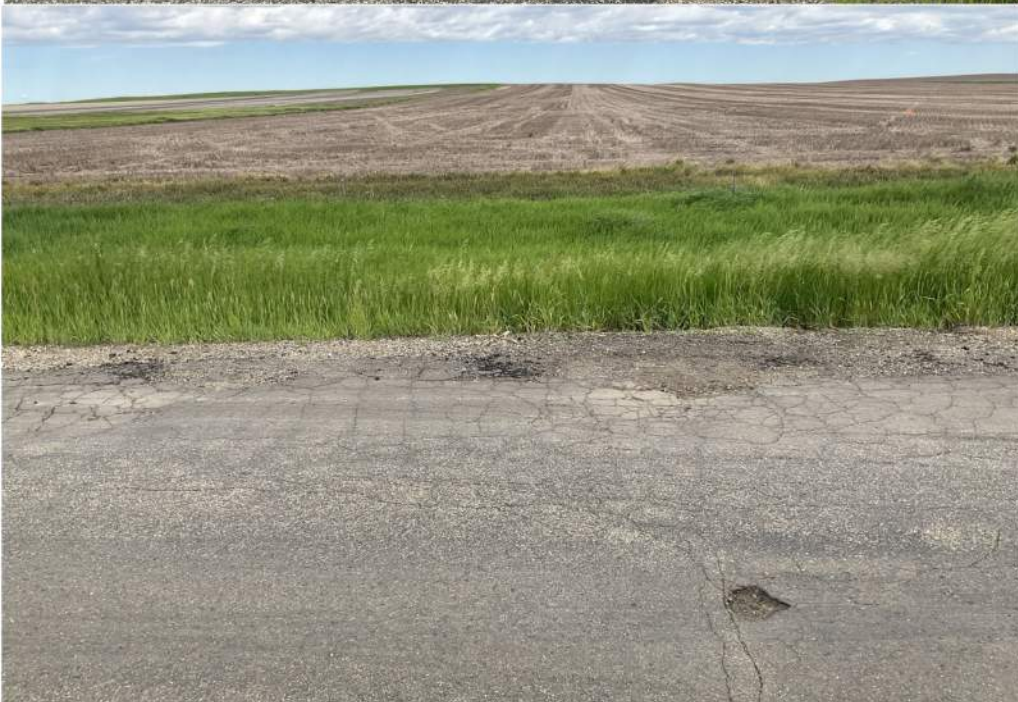
## Asphalt Spot Distress Location

| Route | Post-Con ID | Owner | Location | Primary Distress | Pre-Construction Notes | Post-Construction Notes |
|---|---|---|---|---|---|---|
| 216th St | 2 | Hyde County | 0.15 mi W of 339th Ave | Alligator Cracking | N/A | New post-con condition: Rutting approx 1 inch and distressed asphalt due to turning traffic into the pit.* |

| Notes | New post-con condition: Rutting approx 1 inch and distressed asphalt due to turning traffic into the pit. | | |

\*It is understood that discussions are being held to address the worsened asphalt conditions.

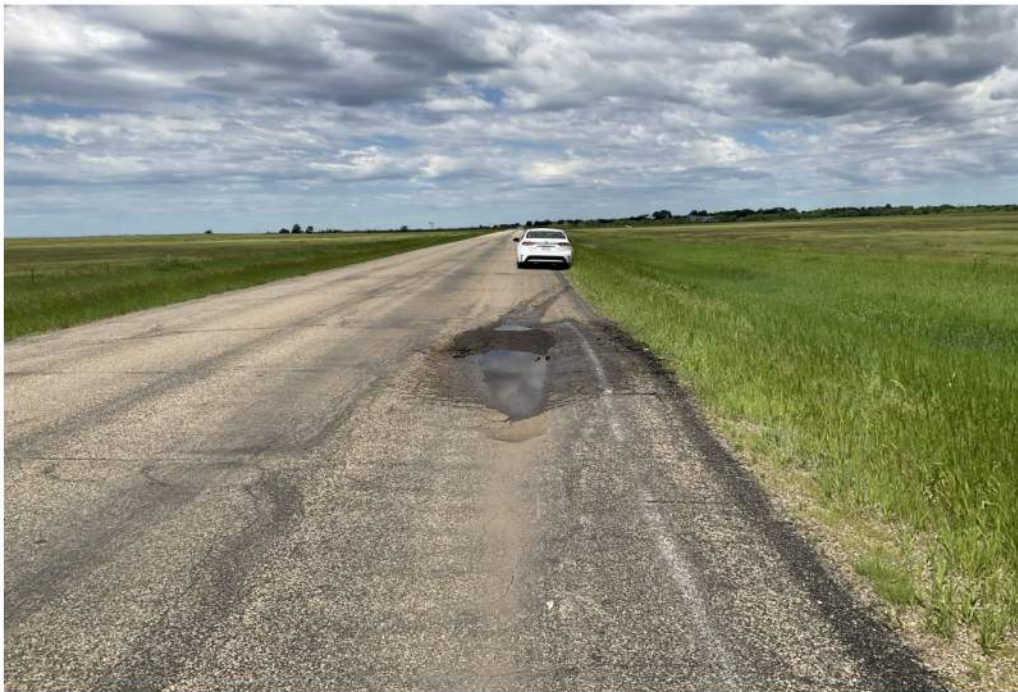
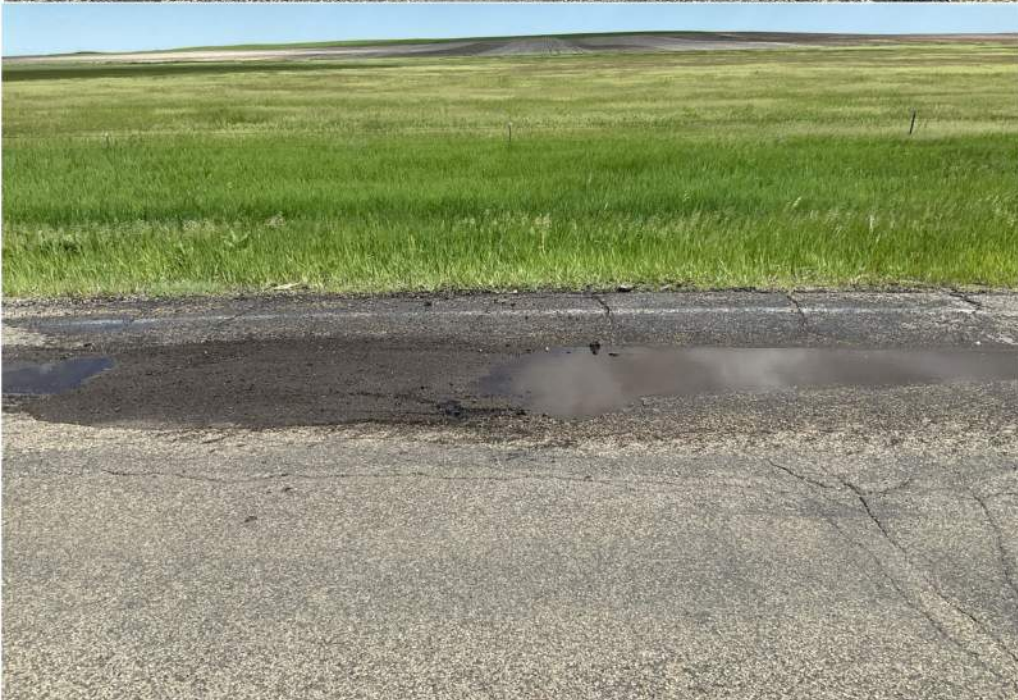
## Asphalt Spot Distress Location

| Route | Post-Con ID | Owner | Location | Primary Distress | Pre-Construction Notes | Post-Construction Notes |
|---|---|---|---|---|---|---|
| 216th St | 3 | Hyde County | 0.3 mi W of 339th Ave | Frost Heave | N/A | New post-con condition: Frost heave and minor patching will continue to deteriorate.* |

| Notes | New post-con condition: Frost heave and minor patching will continue to deteriorate. | | |
