# Waterbody Data Form

| Centerline ID:<br><u>5104HA004</u> | | Project Designated Name:<br><u>KXL Phase IV</u> | |
| Date:<br><u>5/18/10</u> | Client/Project Name:<br><u>TransCanada-TKOW-KXL Phase IV</u> | | Milepost Enter/Exit:<br><u>EMP: 292.35 CAR MP: 1.75</u> |

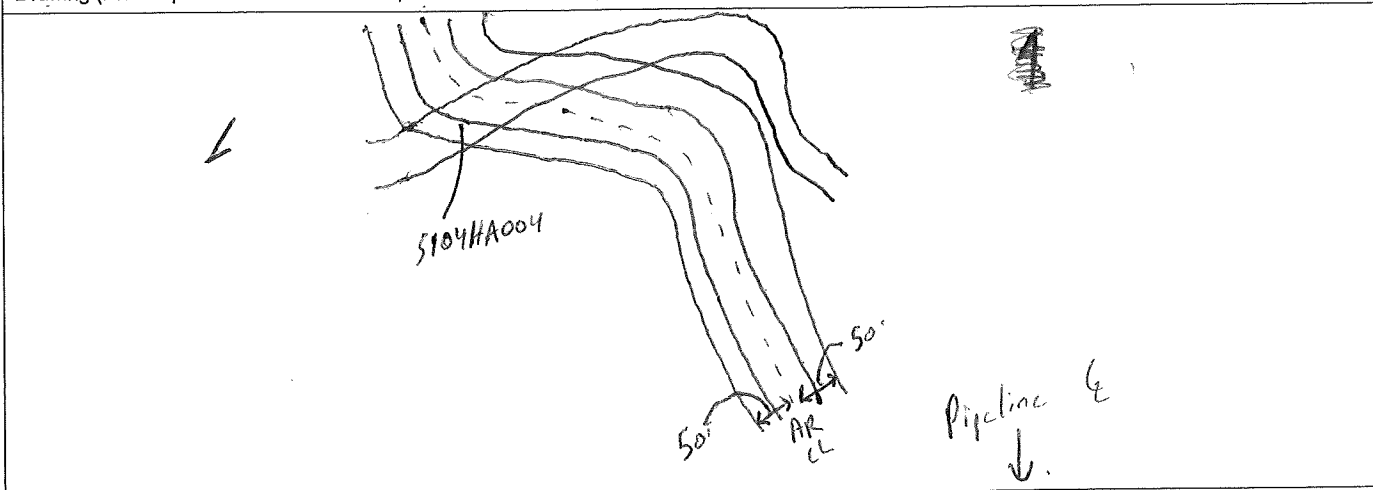
Drawing (Please provide orientation arrow, all features identified, location to centerline, etc.)

| Habitat ID Number: | <i>Shallow intermittent stream with Juncus balticus emerging from it. Banks are very low with the exception of the north bank on the western side of AR.</i> |

| Comments: | <i>Intermittent stream with a low water crossing. Improvements will be needed for equipment to cross especially during the rainy season. Possible culvert location.</i> |
