# Waterbody Data Form

S302 HA007  
CAR 233

| Centerline ID: issued 2012-07-02 | | Project Designated Name: KXL pipeline | |

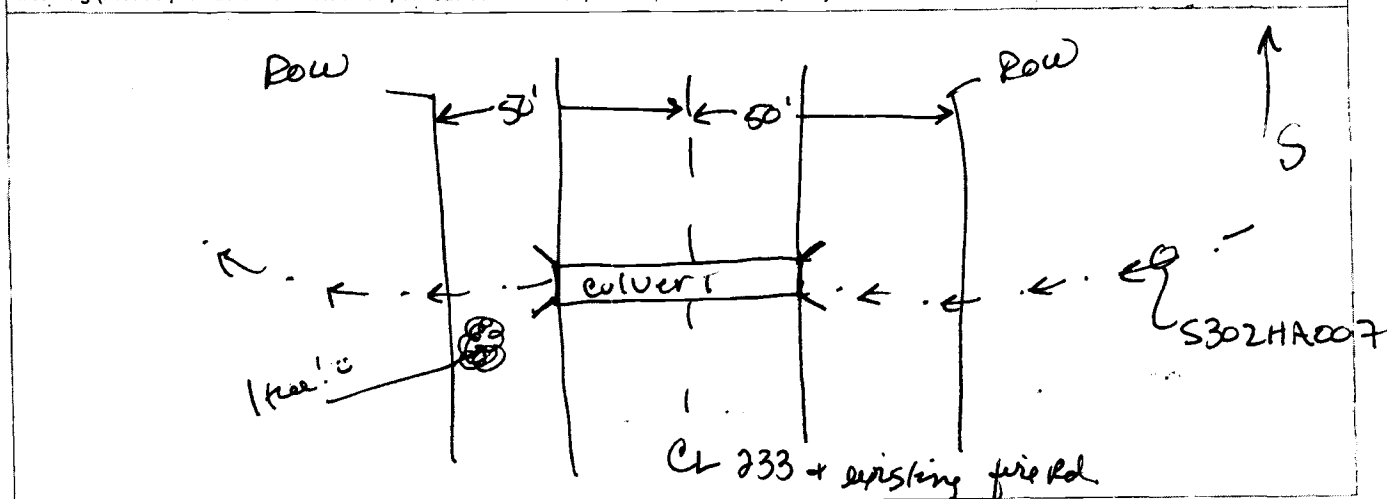
Drawing (Please provide orientation arrow, all features identified, location to centerline, etc.)

| Tributary Condition: <input checked="" type="checkbox"/> Natural <input type="checkbox"/> Artificial (Man-Made) <input checked="" type="checkbox"/> Manipulated - <u>fire Rd. &amp; culvert</u> | | | |
| <input type="checkbox"/> Dikes/Berms | <input checked="" type="checkbox"/> Excessive Bank Erosion | <input type="checkbox"/> N/A | <u>@ Road Xing</u> |

| <u>- disturbed w/in ROW due to existing fire road &amp; culvert pools of standing water outside of ROW.</u> | |
