# Waterbody Data Form

| Centerline ID: 5308 HLL002 | | Project Designated Name: ILXL Pipeline | |
| Date: 7-24-12 | Client/Project Name: | | Milepost Enter/Exit: 447.85 |

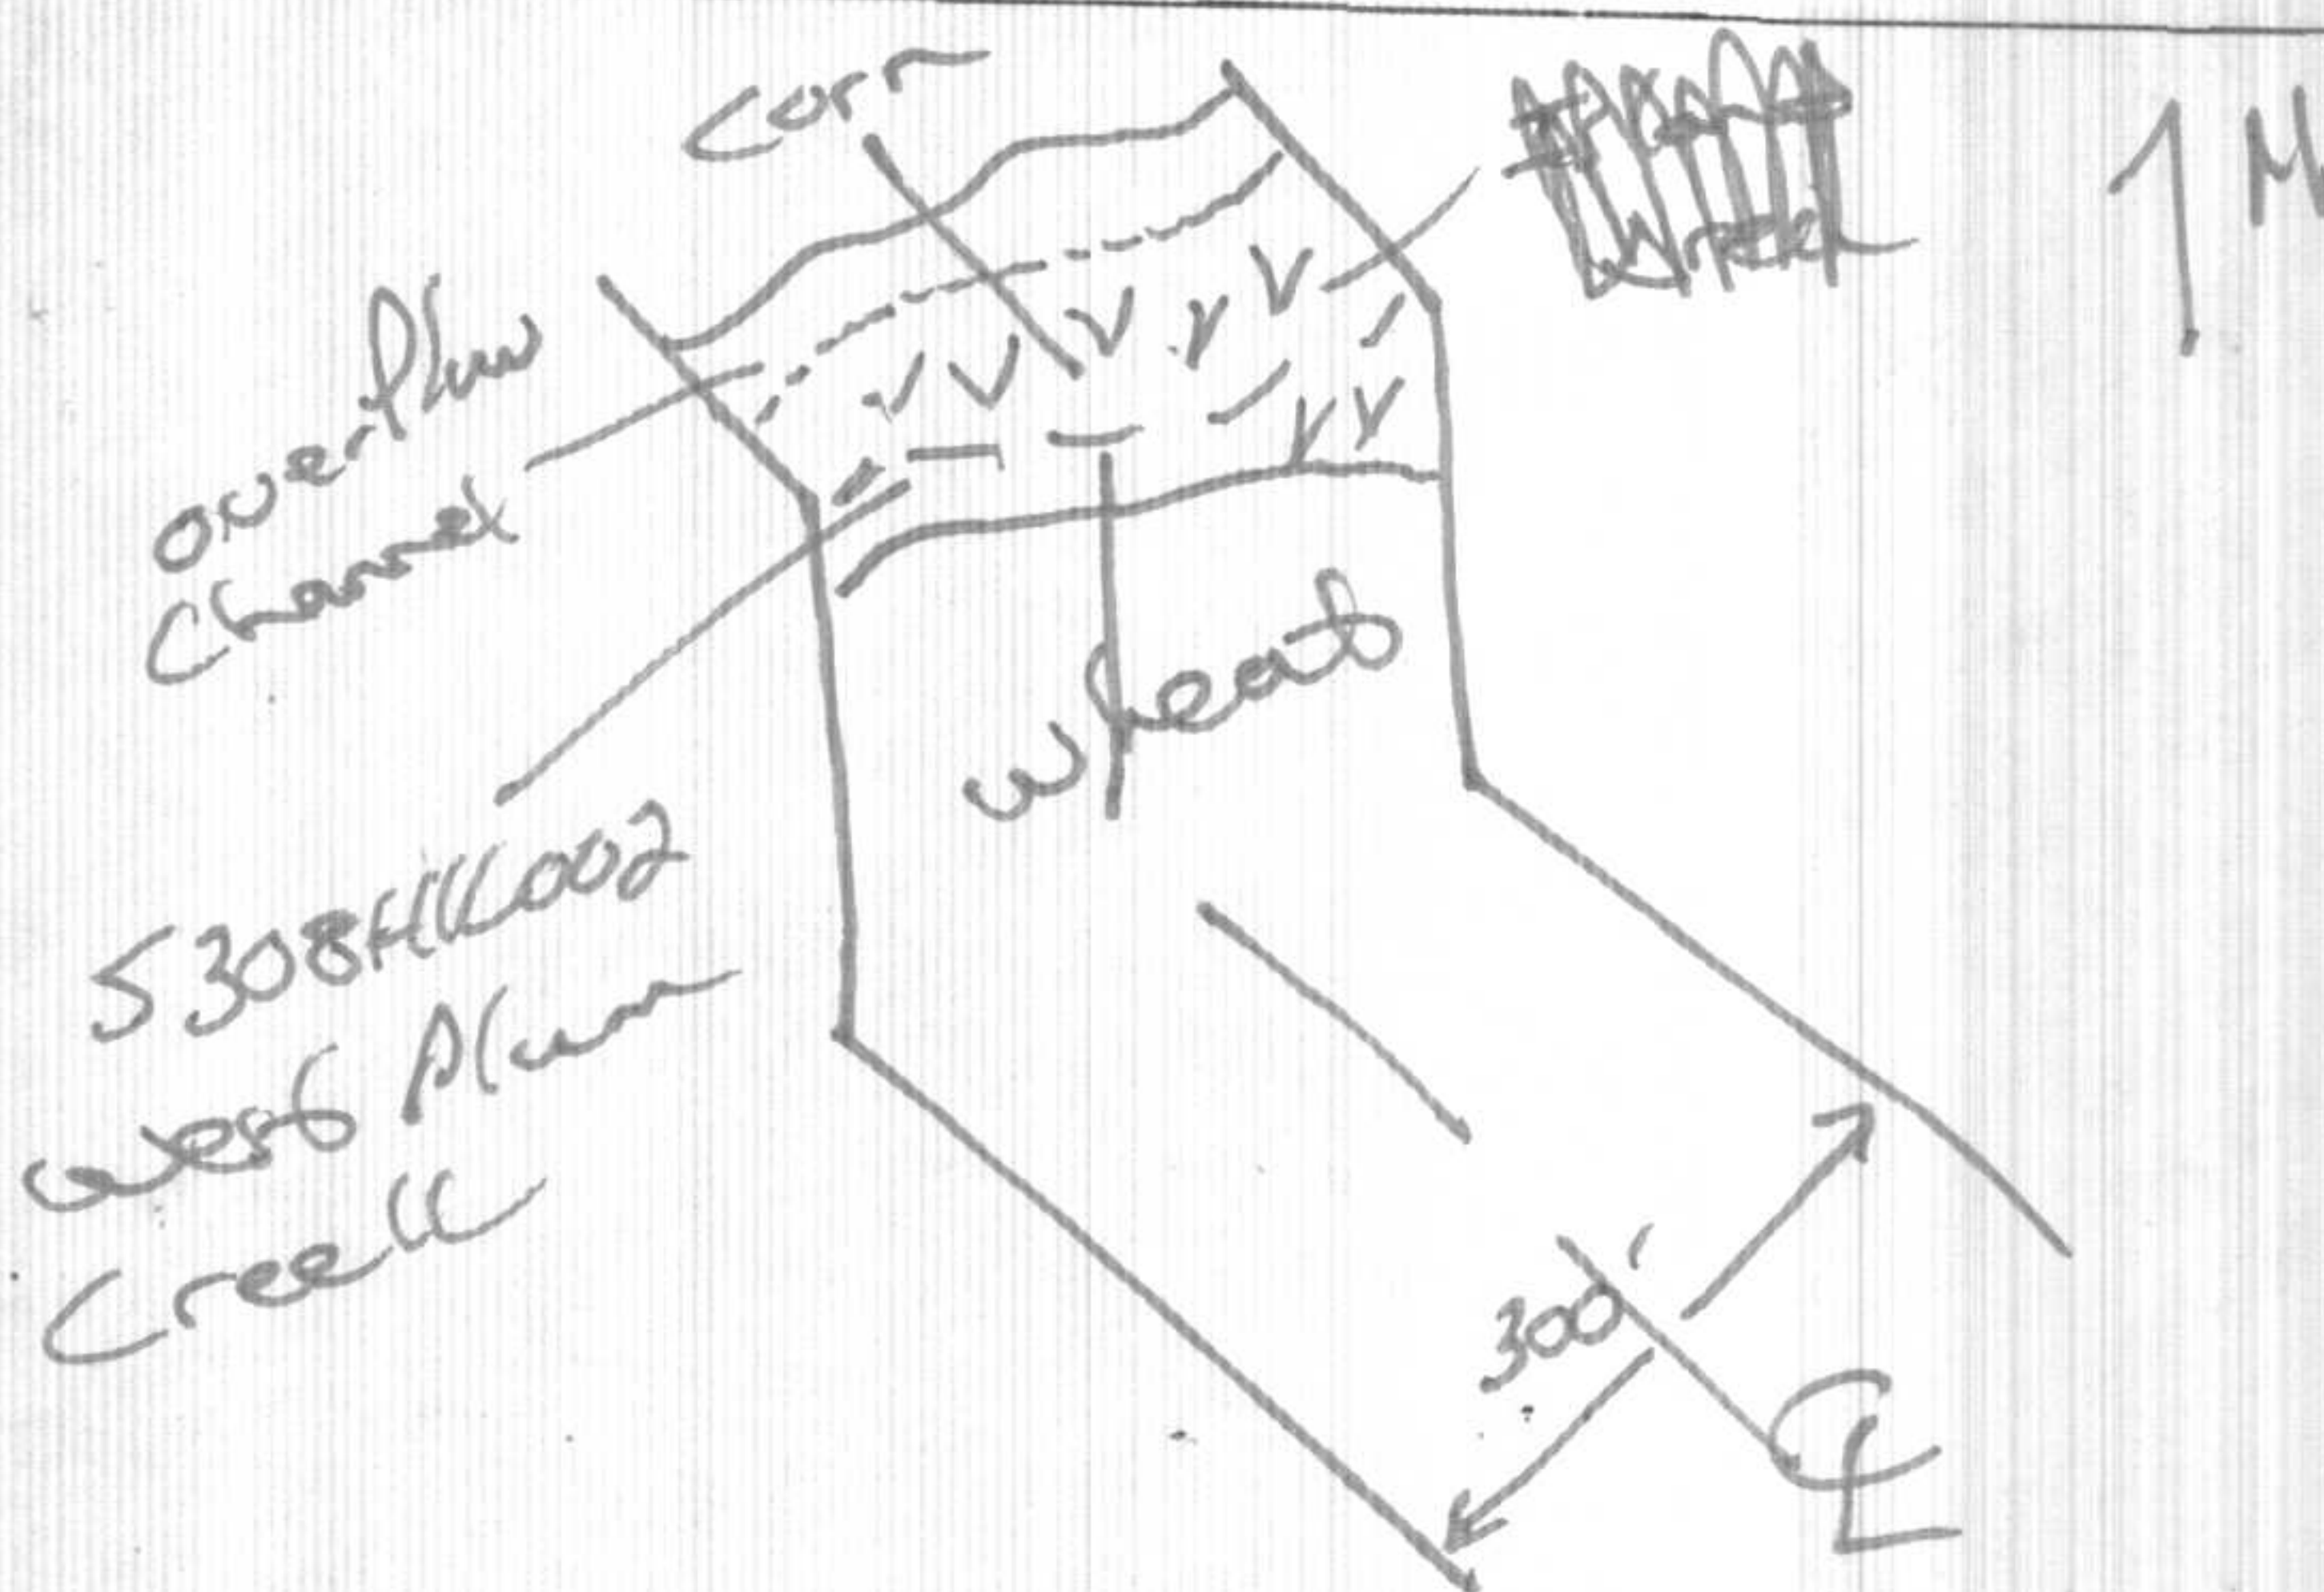
Drawing (Please provide orientation arrow, all features identified, location to centerline, etc.)

| <b>Comments:</b><br>West Plum Creek. Perennial tributary, fish present.<br>Steep slopes. Relatively moderate to high quality tributary.<br>Appears to occasionally possess a significant flow. | |
