# Waterbody Data Form

| Centerline ID: <u>S308HK003</u> | | Project Designated Name: <u>KXL</u> | |
| Date: <u>7-26-12</u> | Client/Project Name: | | Milepost Enter/Exit: <u>CAK-235 (0.05/0.29-0.38/0.42-0.44)</u> |

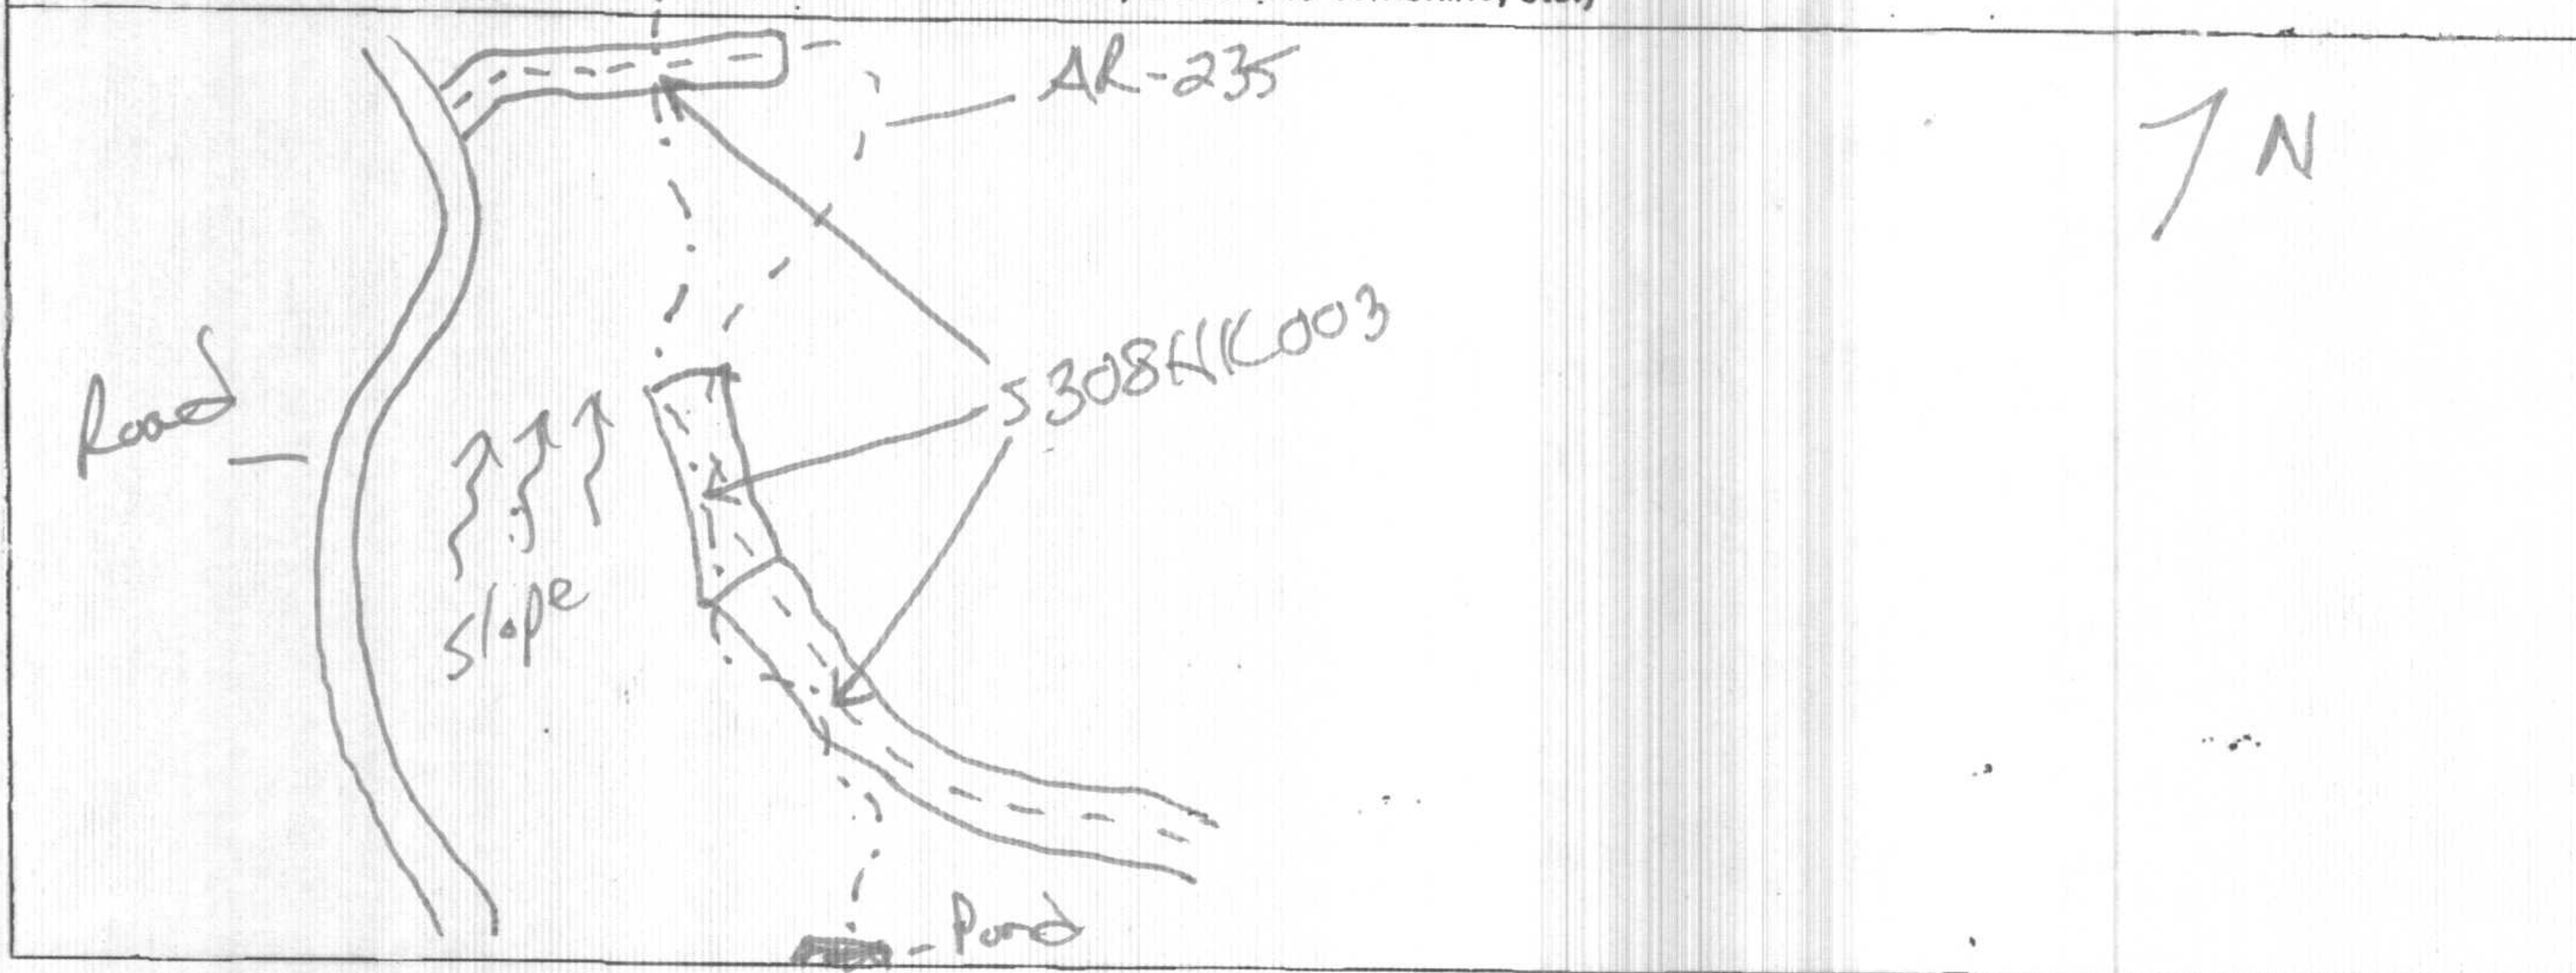
Drawing (Please provide orientation arrow, all features identified, location to centerline, etc.)

| <i>Tributary of Bob River. Waterbody has been altered by damming a pond upstream. Waterbody is influenced largely by the pond and afterflow. The tributary enters the survey area at 3 different locations and generally drains along a section of CDL-235.</i> |
