# HAUL ROUTE INSPECTION REPORT

HUGHES COUNTY, SOUTH DAKOTA  
**NORTH BEND ROAD USE AGREEMENT**  
Post-Construction Report

PROJECT NUMBER: 2302136

DATE: 05/31/2024

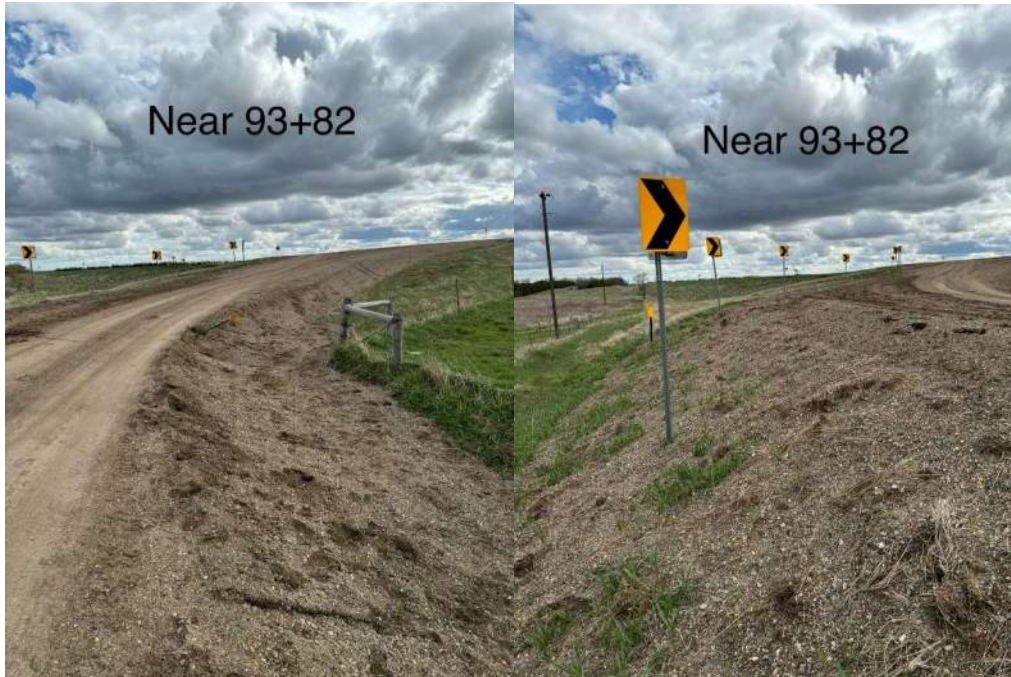
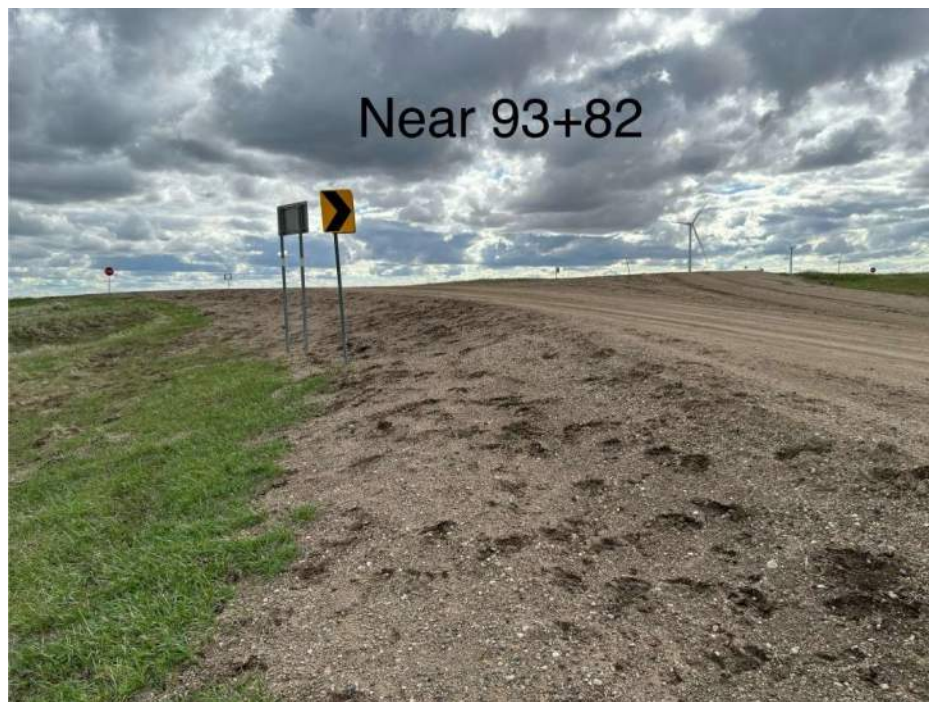
**324<sup>TH</sup> AVENUE**

One area near STA 93+82 was negatively impacted on this haul route. This location is along the curve just north of the intersection with 204<sup>th</sup> Street. It appears that gravel has been added to widen the road to allow trucks to make it around the curve. The added gravel was loose and uncompacted. This area is severely rutted. A large amount of gravel has been pushed off the shoulder of the road and lays on the foreslope and in the ditch on both sides. Pictures of the visual observation of this area can be found in Appendix D. The gravel thrown off the road has also caused issues with the culvert at STA 93+82. The right end of the culvert was buried in gravel. It appears to have cleared out a little from stormwater washing it out.

- Vegetation Re-establishment at Approaches & Tie-Ins, see 7.6.
- Vegetation Re-establishment at intersection with 203<sup>rd</sup> Street, see 7.6.
- Major Shoulder pull: approximately 0.08 miles at intersection with 204<sup>th</sup>, see 7.6.

| Segment | Secondary Location | Concern | Restoration | Rate | Unit | Amount | Cost |
|---|---|---|---|---|---|---|---|
| | 204th Street Intersection | Lost Gravel | Major Shoulder Pull | \$ 4,000.00 | LS | 1 | \$ 4,000.00 |
