## EVALUATION REPORT OF LIQUID PIPELINE CONSTRUCTION

| Inspection Report | | Post Inspection Memorandum | |
|---|---|---|---|
| Name of Operator: | TransCanada Oil Pipeline Operations Inc. | OPID #: | 32334 |
| Name of Unit(s): | Keystone Gulf Coast Pipeline North / Keystone Gulf Coast Pipeline South | Unit #(s): | 74979,83245 |
| Inspection Type: | Construction | Inspection Date(s): | 2011-2014 |

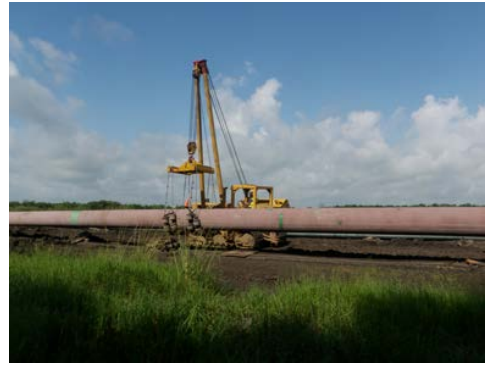
**Figure 10: Boom holding Pipe**

To avoid many road and railroad crossings, other pipeline, bodies of water and any other encroachments, TransCanada horizontally directional drilled (HDD) the pipeline at these locations. The depth of the HDDs well exceeded the depth of cover required by the regulations. PHMSA witnessed and inspected HDD construction activities for any issues and to assure specifications were followed. The Figures demonstrate the inspection of the HDDs. Figure 10 shows pipe is being supported by a boom as it is being pulled into the drill.

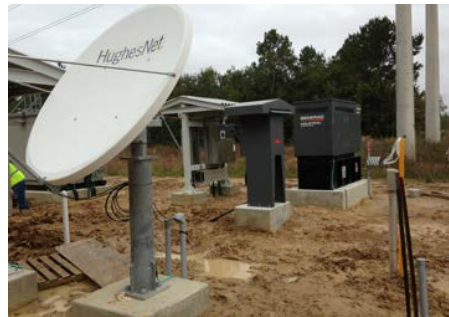
**Figure 14: Remote Operation Equipment at Valve site.**

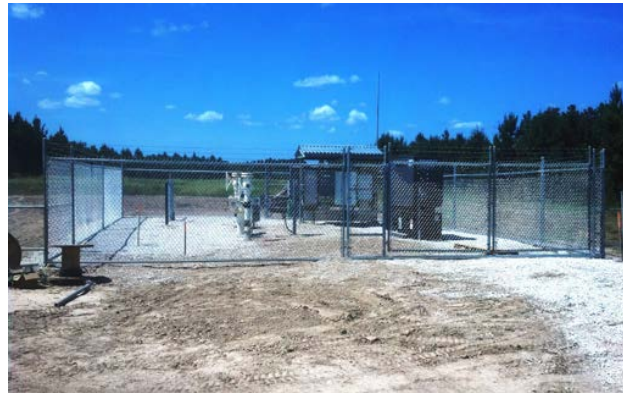
All valves are motorized and remotely operational through SCADA. All valves had concrete foundation poured to handle any stresses the weight may put on the pipeline. Figure 17 is an example of concrete supports. Figure 18 demonstrates the protection from unauthorized personnel and vandalism. In addition, the photos show the satellite, electric power and generators for backup needed to operate the valves.

**Figure 18: Typical Fencing around Valve site**

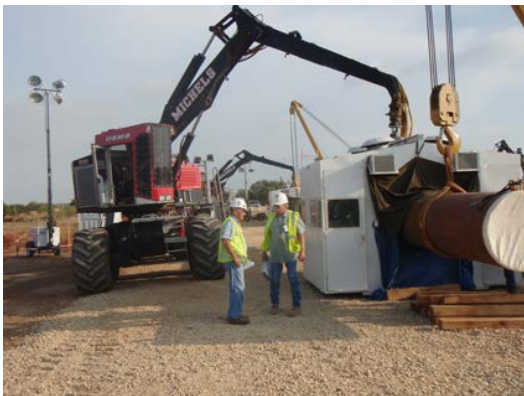
**Figure 20: Automatic Welding Shack**

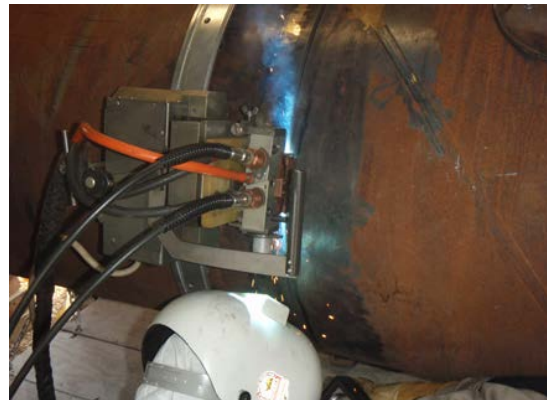
**Figure 21: Automatic Welding Set up**

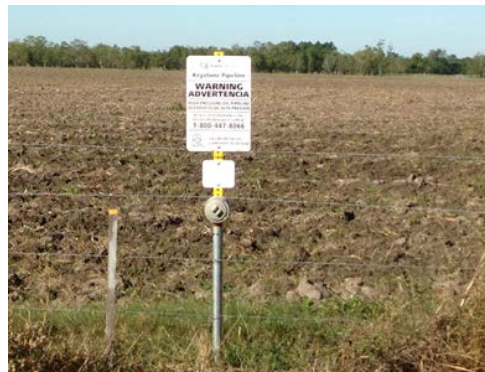
**Figure 24: Typical Test Station**

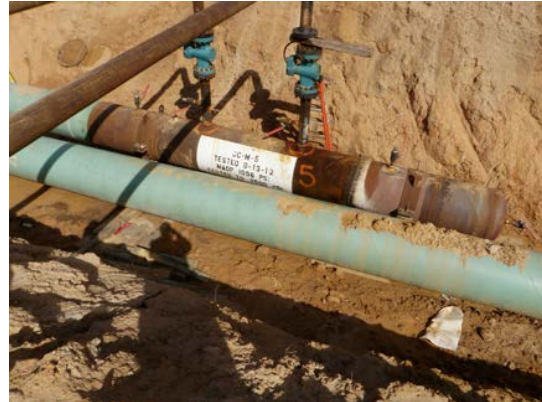
**Figure 28: Hydrotest in Progress**

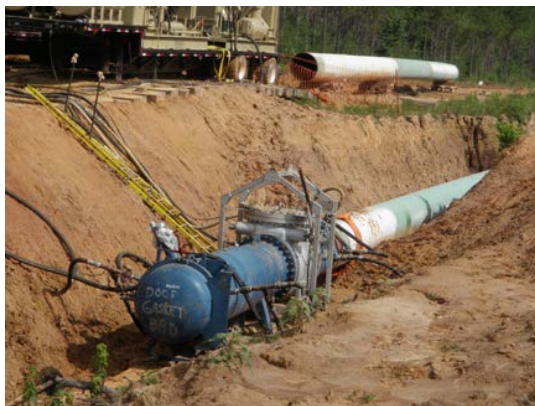
The entire pipeline was hydrotested to at least 8 hours for all buried pipelines. In addition, TransCanada conducted a one hour pressure test on all HDD piping before pulling the pipe section. The one hour test is part of TransCanada's procedures to verify the integrity of the HDD pipe before pulling it through the drilled hole. The test medium used for all testing was water. All records reviewed had documented the appropriate pressure of 125% or more of MOP, test medium, instrument calibration, pressure recording charts, temperature, date and time and description of the facility being tested. TransCanada also provided elevation profiles of all test sections with hydraulic pressure profiles. There were no leaks or failures detected in the records review and during the field inspections.

**Figure 29: Drying process after hydrotest**

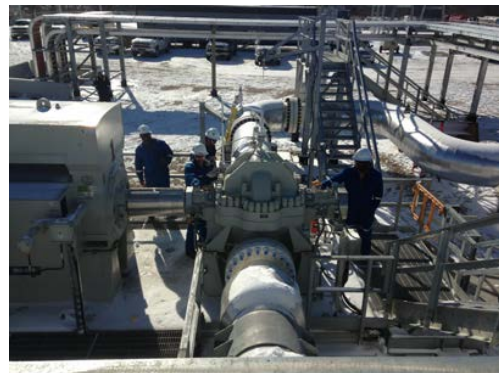
**Figure 31: Commissioning at Pump Station**
