## EVALUATION REPORT OF LIQUID PIPELINE CONSTRUCTION

| Inspection Report | | Post Inspection Memorandum | |
|---|---|---|---|
| Name of Operator: | TransCanada Oil Pipeline Operations Inc. | | OPID #: 32334 |
| Name of Unit(s): | Keystone Gulf Coast Pipeline North / Keystone Gulf Coast Pipeline South | | Unit #(s): 74979,83245 |
| Inspection Type: | Construction | | Inspection Date(s): 2011-2014 |

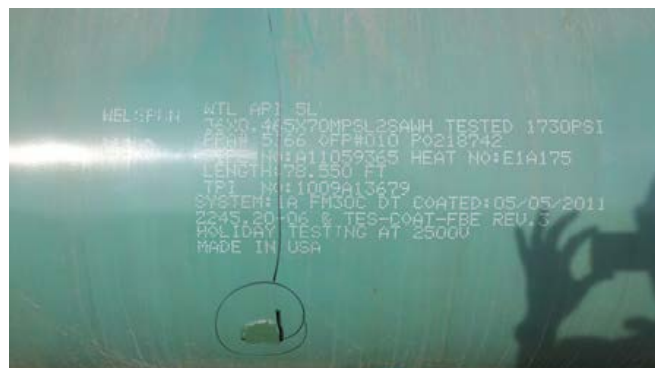
Figure 2: Pipe Specification Markings

During the field inspections, the pipeline was verified for design specifications by examining the pipe for manufacturer stamping and reviewing manufacturer test reports (MTRs). Each pipe joint was marked with length, grade, pipe size, and specification. See Figures 1 and 2 for examples.

Pipe used for the construction had different wall thicknesses for different application locations such as: 0.465" for line pipe, 0.515" for HCAs, 0.572" downstream of pump station, 0.618" for road bores, and 0.748" for HDDs. HDD and road bore pipe also had abrasion resistant overcoat (ARO) which was verified during the field inspections as seen in Figure 3. Pipe joints were marked with the appropriate specifications, for example, API 5L PSL2 36", 0.465", X70.

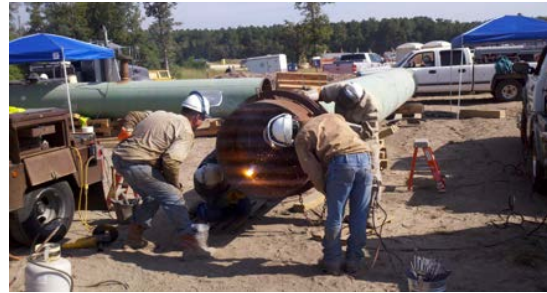
**Figure 19: Welder Qualification Test**

Throughout the construction project, PHMSA reviewed welding procedures, specifications and conducted field observations of welding activities. In addition, PHMSA witnessed the qualification of procedures and welders to assure welding was being performed to a qualified procedure and by qualified welders.
