## Post-Construction Haul Route Evaluation Report

North Bend Wind Project  
Hyde County, South Dakota  
UEI Project No. 23.22932

*Prepared for  
Hyde County, South Dakota*

*Prepared by  
Ulteig Engineers, Inc.  
July 2024*

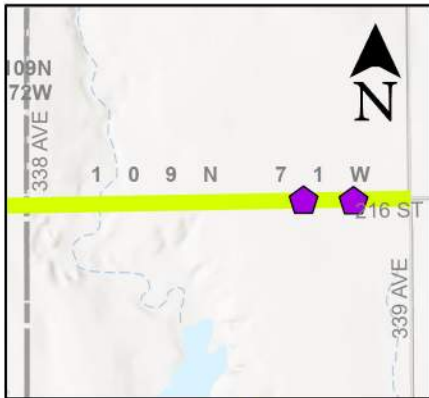
Asphalt PASER Condition: 216th St -- 338th Ave to 339th Ave

| ID | 1 | Apparent Recent Maintenance | Seal Coat/Chip Seal |
| Owner | Hyde County | Primary Distress Type | Block Cracking |

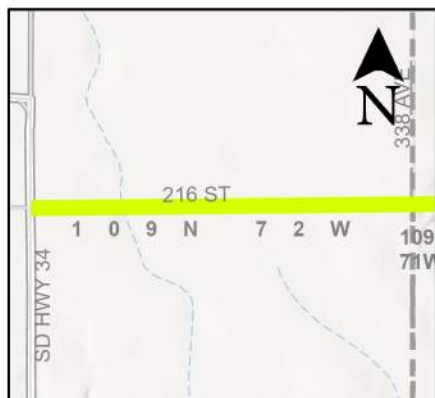
Asphalt PASER Condition: 216th St -- SD HWY 47 to 338th Ave

| ID | 2 | Apparent Recent Maintenance | Seal Coat/Chip Seal |
| Owner | Hyde County | Primary Distress Type | Block Cracking |

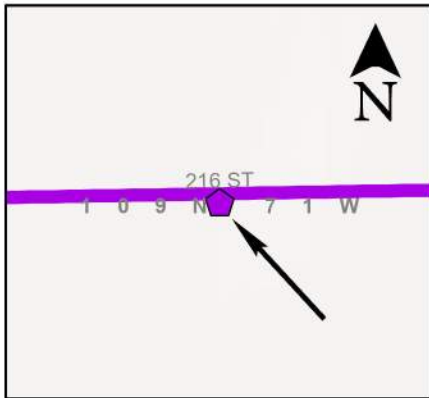
## Asphalt Spot Distress Location

| ID | 2 | Primary Distress Type | Alligator Cracking |
| Lat/Long | 44.252227, -99.404303 | Secondary Distress Type (1) | Rippling/Shoving |

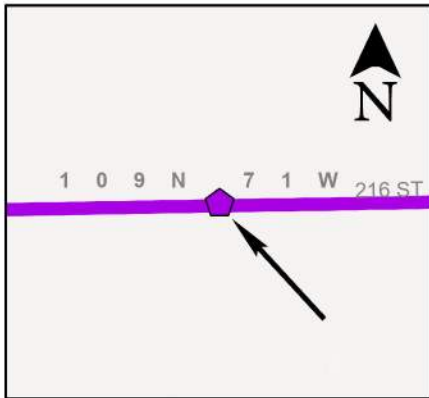
## Asphalt Spot Distress Location

| ID | 3 | Primary Distress Type | Frost Heave |
| Lat/Long | 44.252246, -99.406922 | Secondary Distress Type (1) | Rutting |
